STATE OF CALIFORNIA  
BUSINESS AND TRANSPORTATION AGENCY  
DEPARTMENT OF PUBLIC WORKS  
DIVISION OF HIGHWAYS

# AN EXPERIMENT USING EMULSIFIED ASPHALT COLD MIX AS A SURFACING MATERIAL

72-54

March 8, 1972

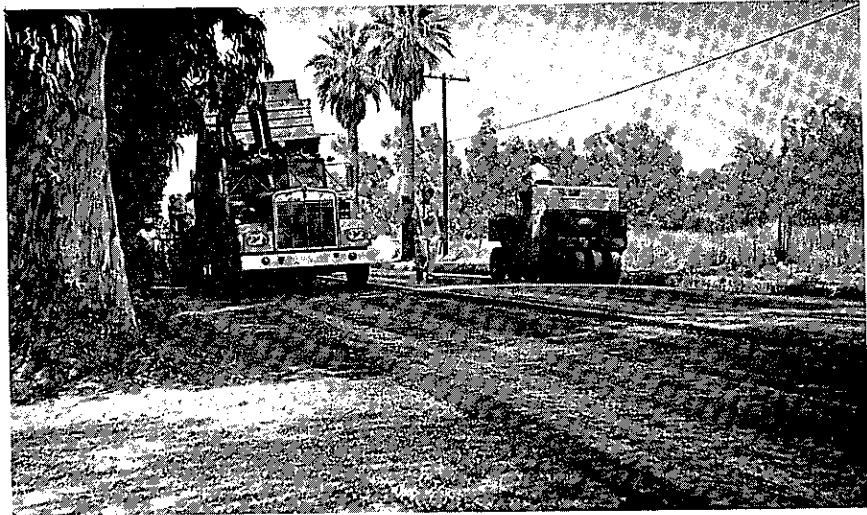
The sand choker was placed by backing a dump truck with the bed inclined about 30° over the mixture (Figure 7). The first sand choker applied was seen to nearly hide the mixture with an estimated cover of 1/8" and was felt to be excessive. Subsequent amounts (after the first 100' of the first paved lane) were reduced so as to give the appearance of a lightly scattered sand effect.

**Figure 7**  
**APPLYING**  
**SAND CHOKER**

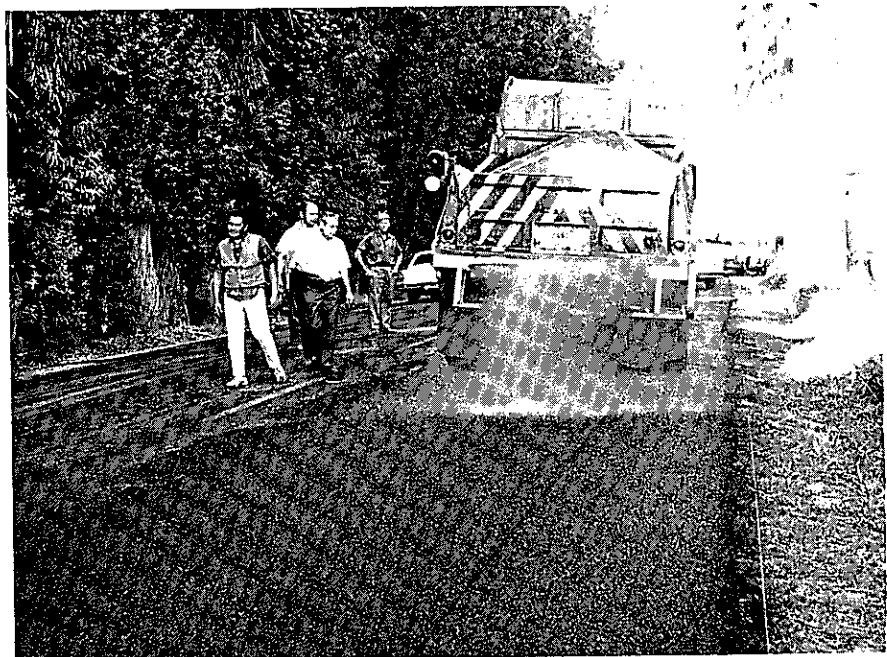
graded mixture did not have a sand choker applied. This mixture after placing appeared to take longer to cure and several wet spots could be detected (Figure 8). After 4 to 6 hours the entire surface of the dense graded mixture was covered by a film of free water.

**Figure 8**  
**WET SPOTS FROM**  
**EMULSION APPEARING**  
**IN DENSE GRADED,**  
**SOON ENTIRE SUR-**  
**FACE APPEARED WET.**

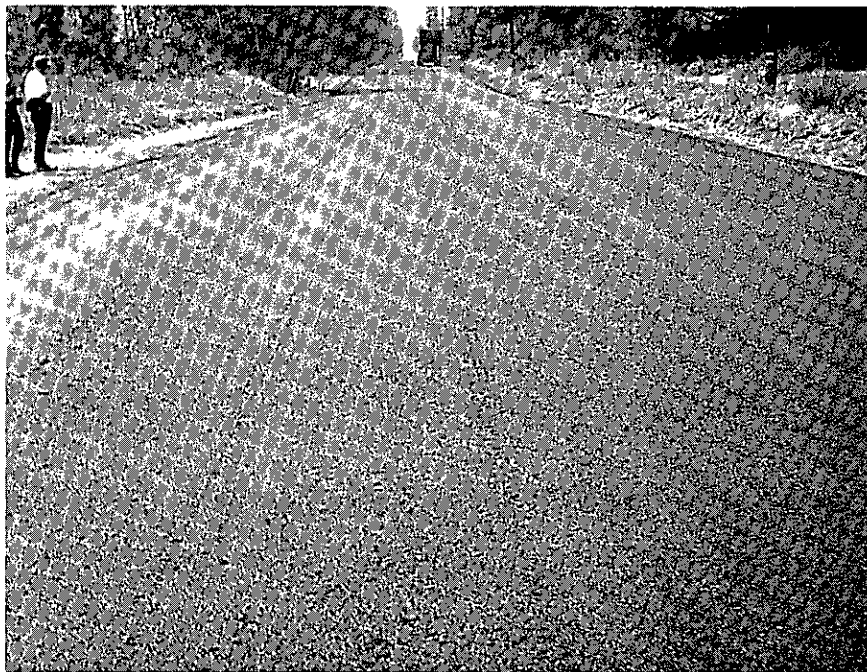
Figure 11  
1 HR. AFTER FOG SEAL

There was also some visual evidence that the mixture had not cured completely. For example, a 2-foot section near each edge of the pavement appeared brownish compared to the rest of the pavement, which indicated the asphalt still was emulsified (Figure 10). The wheel track areas appeared black and cured; however, this apparently was only the surface and not indicative of the full depth. The fact that this area was not sufficiently cured in depth was confirmed a few hours later when a fog seal was applied consisting of CSS-1h emulsion diluted 3:1 and applied to obtain a theoretical 0.10 gal. per sq. yd. residue. Traffic was allowed immediately over the sealed area and as the emulsion in the fog seal began to break, it stuck to both tires and surfacing. The result was serious tearing and raveling of the surface (Figure 11). Rocks ripped from the surface were being thrown by the tires of fast moving traffic creating a hazard. Sand was immediately brought out and placed on the surface to blot the emulsion. This was successful and additional raveling and tearing of the surface was arrested.

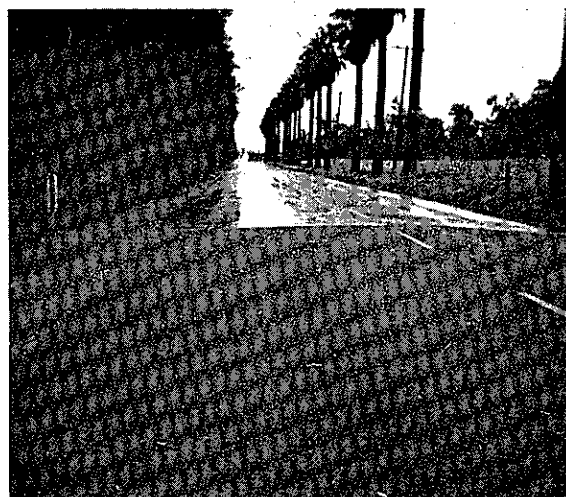
rainstorm. Figure 16 shows the comparison between the cold mix dense graded and the open graded during the same rainstorm.

Figure 16  
CONTRAST DURING RAIN,  
OF COLD DENSE GRADED &  
COLD OPEN GRADED
